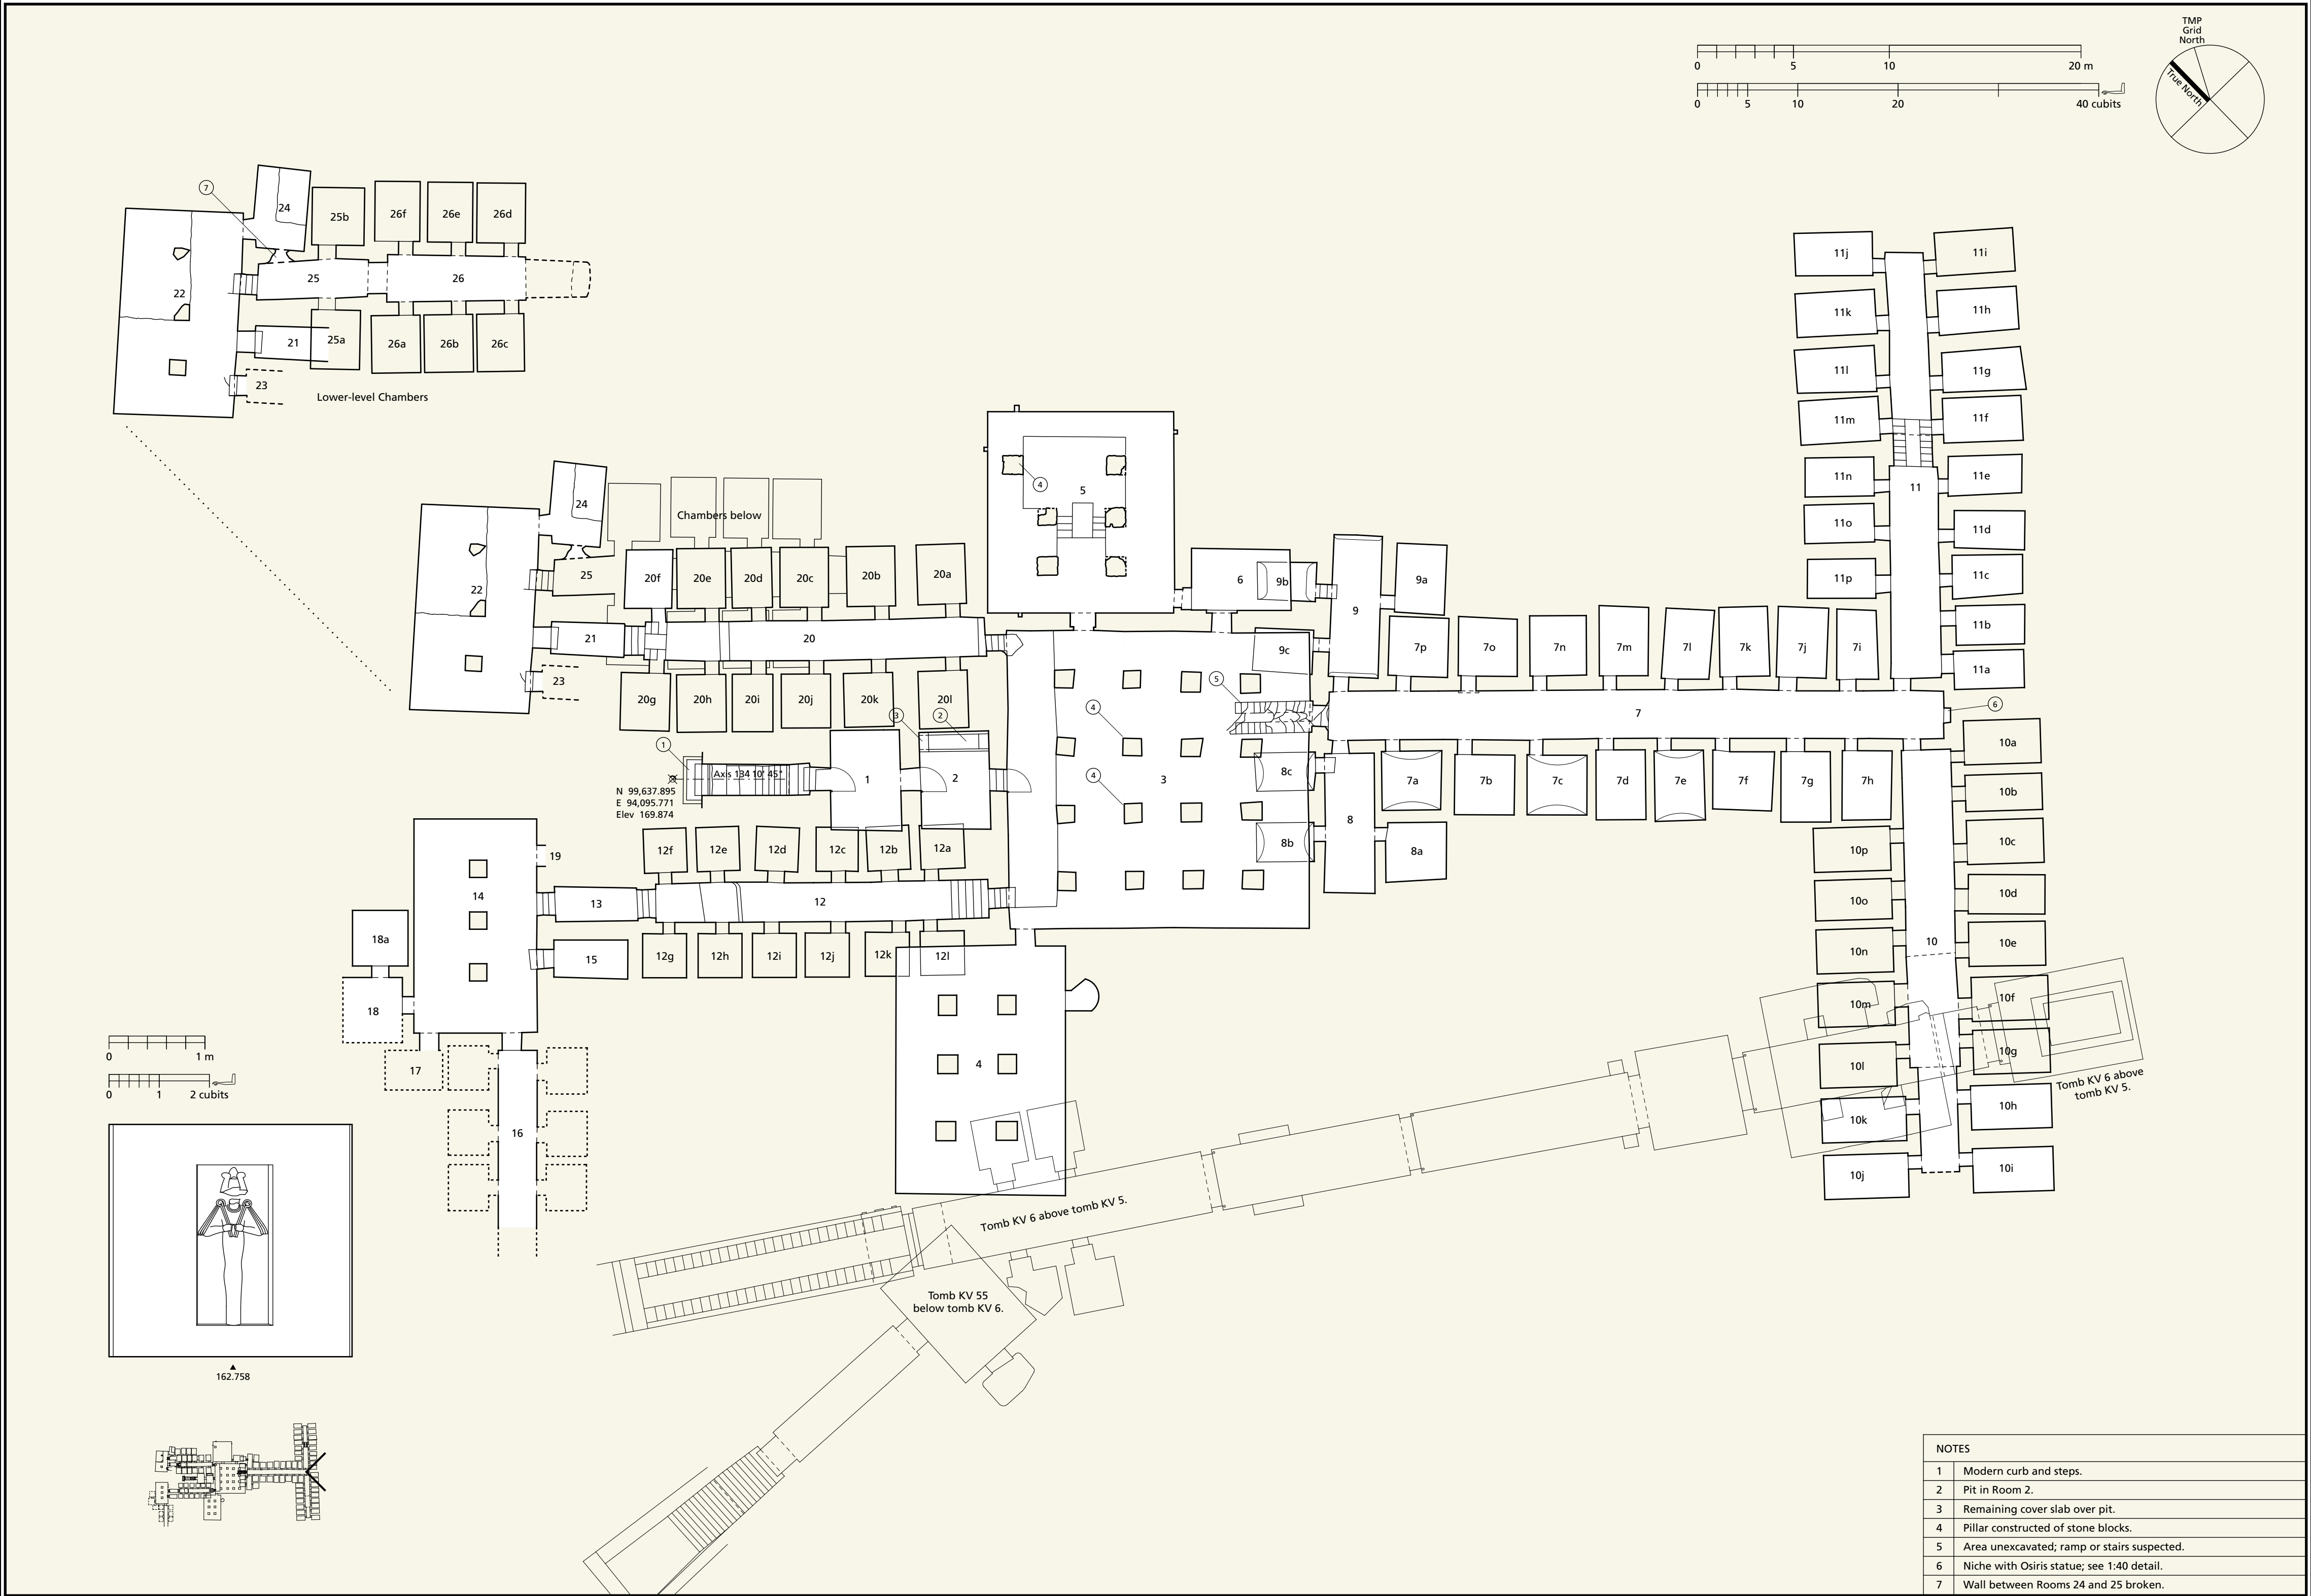
| NOTES | |
|---|---|
| 1 | Modern curb and steps. |
| 2 | Pit in Room 2. |
| 3 | Remaining cover slab over pit. |
| 4 | Original floor level. |
| 5 | Niche with Osiris statue; see 1:40 detail on KV 5 sheet 1/4. |
| 6 | Wall between Rooms 24 and 25 broken. |
| 7 | Ceiling collapsed. |

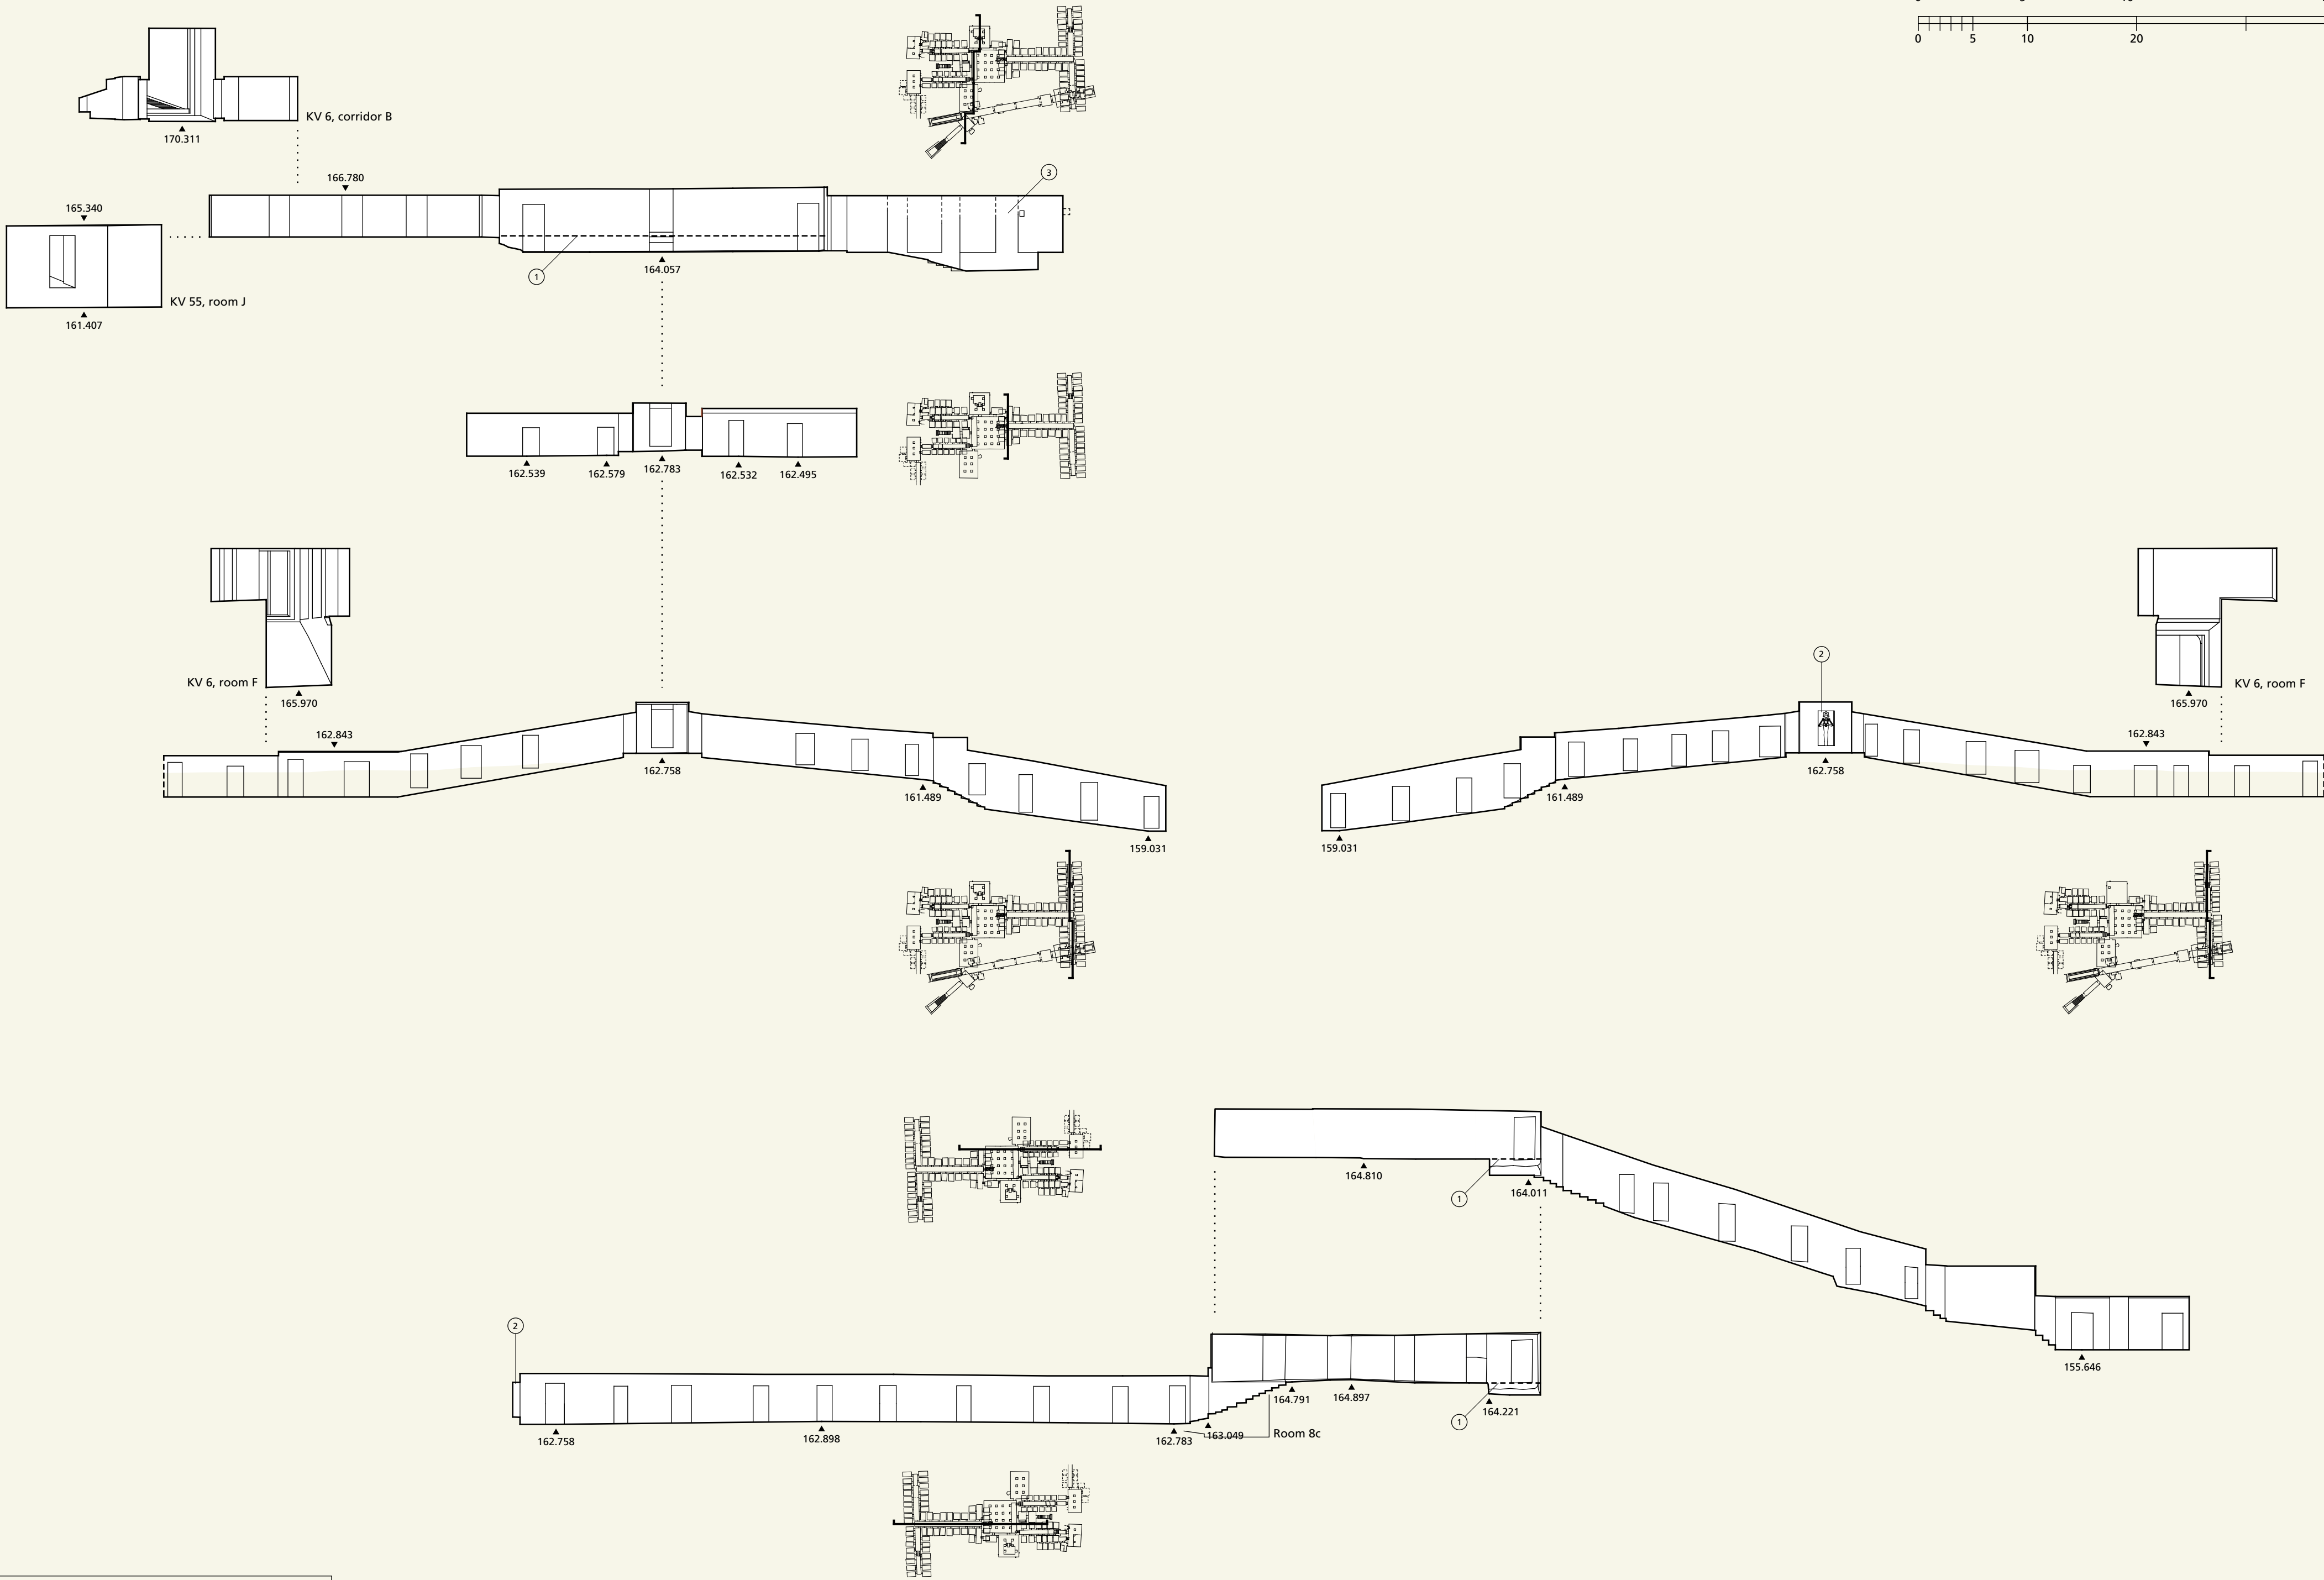
| NOTES | |
|---|---|
| 1 | Original floor level. |
| 2 | Niche with Osiris statue; see 1:40 detail on KV 5 sheet 1/4. |
| 3 | Pillar constructed of stone blocks. |
